PEAK ACCELERATION DEVICE (PAD)

Paul Ibanez, John F. Gray

Final Report for Period April 1985 - December 1986

AVIATION APPLIED TECHNOLOGY DIRECTORATE

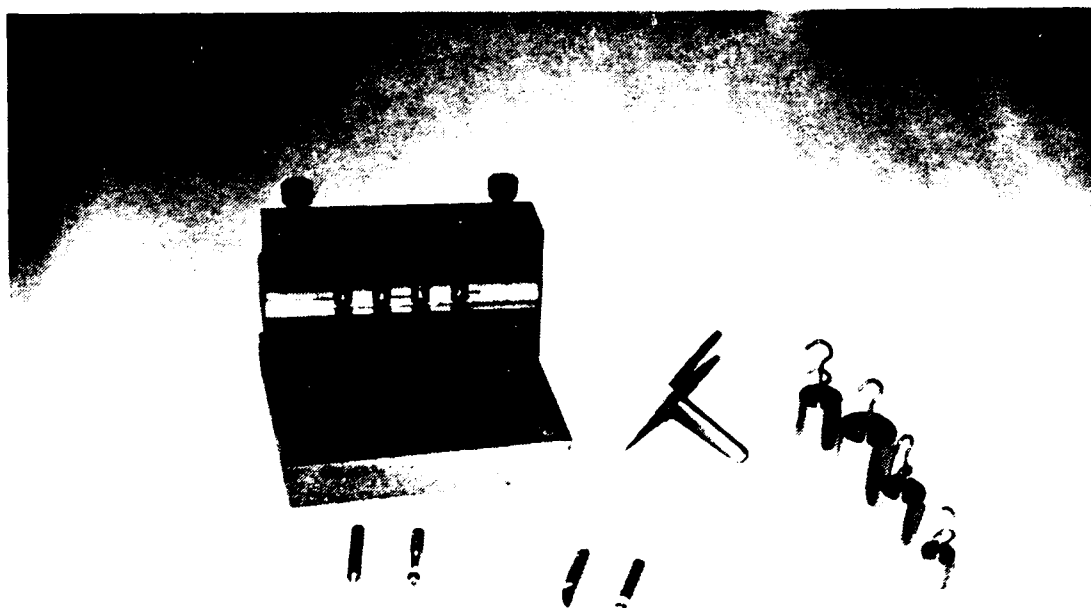
Figure 33. Static test fixture (foils).

During testing, foil samples are clamped between the upper body and the base plate, which are aligned by two registration pins (an important requirement to ensure uniform conditions of loading from test to test). Four cylindrical slugs are used to pierce the foil. They are guided vertically by the body and are loaded with brass weights by means of a special loading platform. The horizontal slot in the body permits viewing of the cylindrical slug during loading so that the process can be stopped once penetration is achieved.

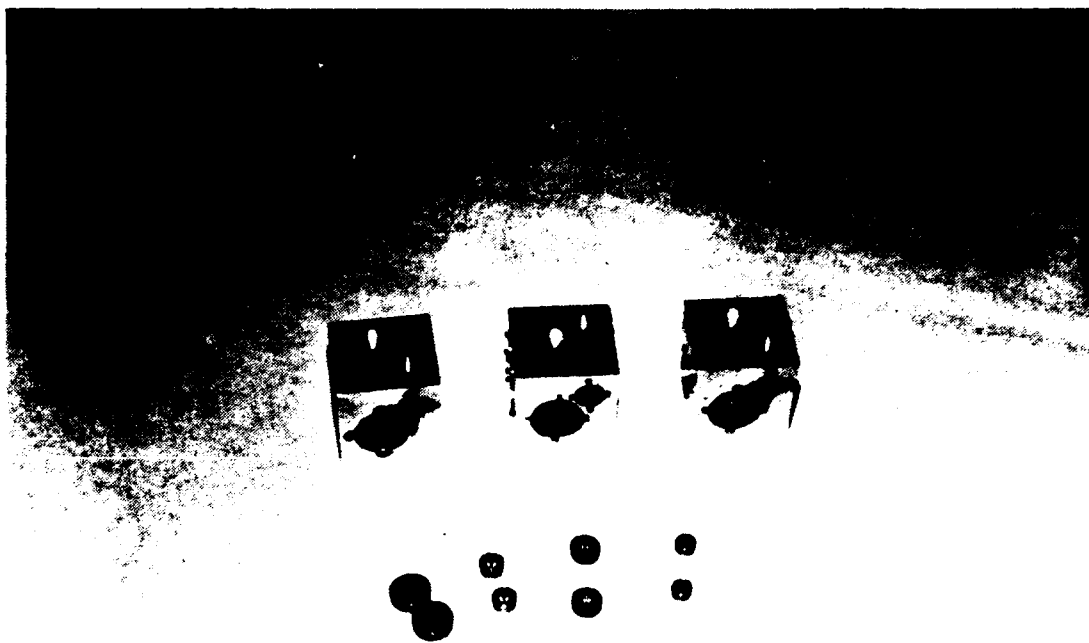
Figure 35. Dual-filament fixtures.

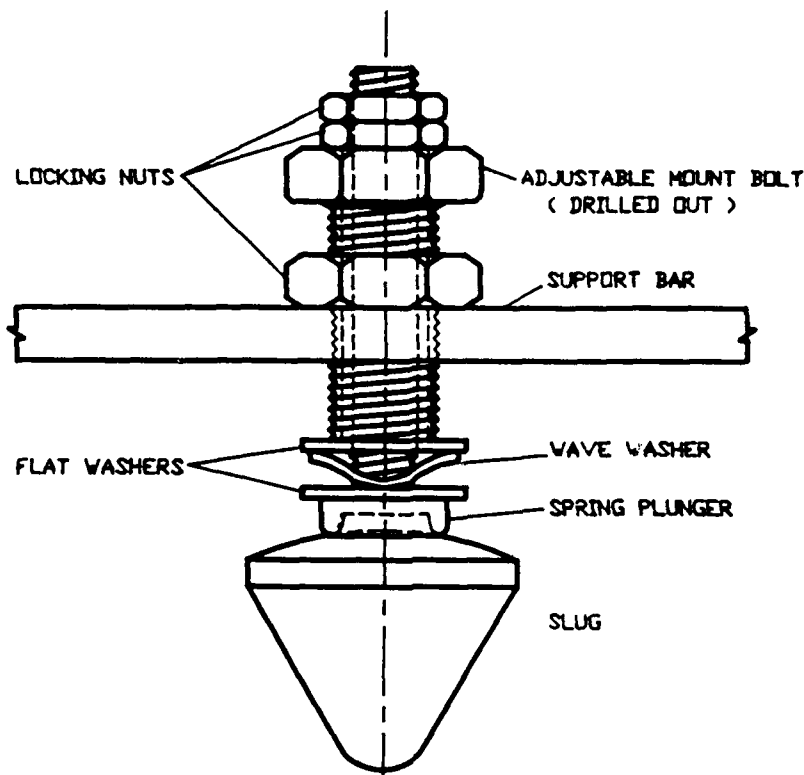
Figure 37. Conical test fixture, threshold spring assembly.

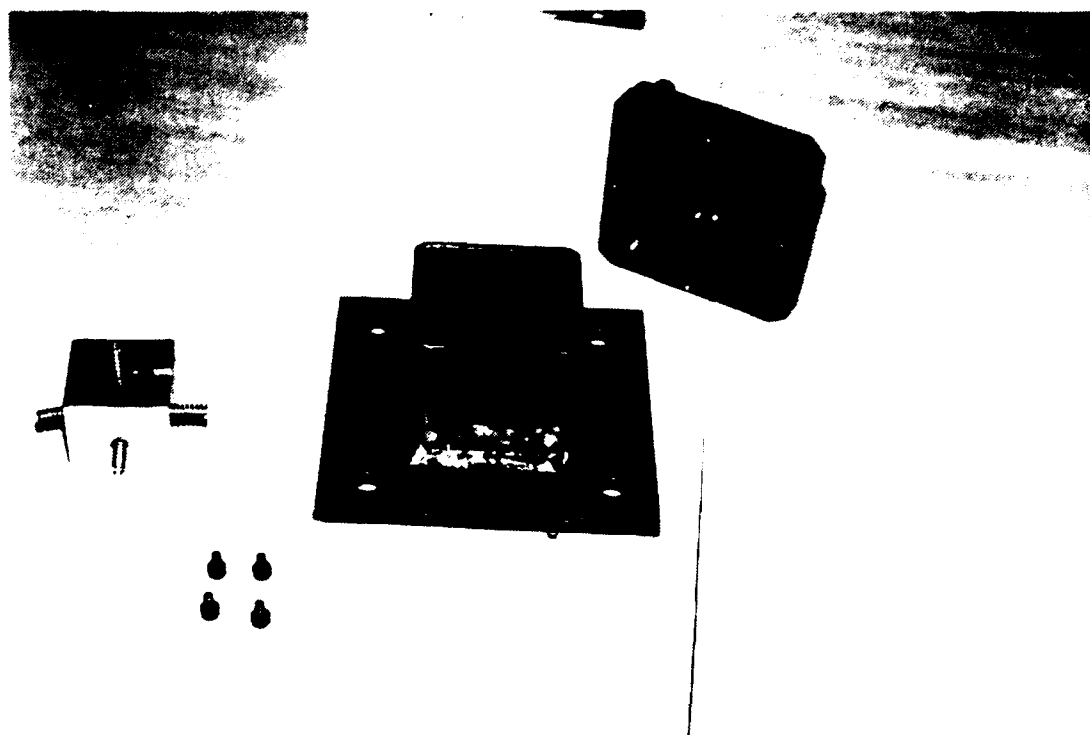
Figure 38. Isolation fixture.

The testing of the isolation characteristics of conical springs was conducted with the housing and data acquisition system previously used for testing compression springs. A smaller cube (1 inch) and a pair of special adaptor plates were used for locating and spacing the conical springs. Figure 40 shows the fixture.

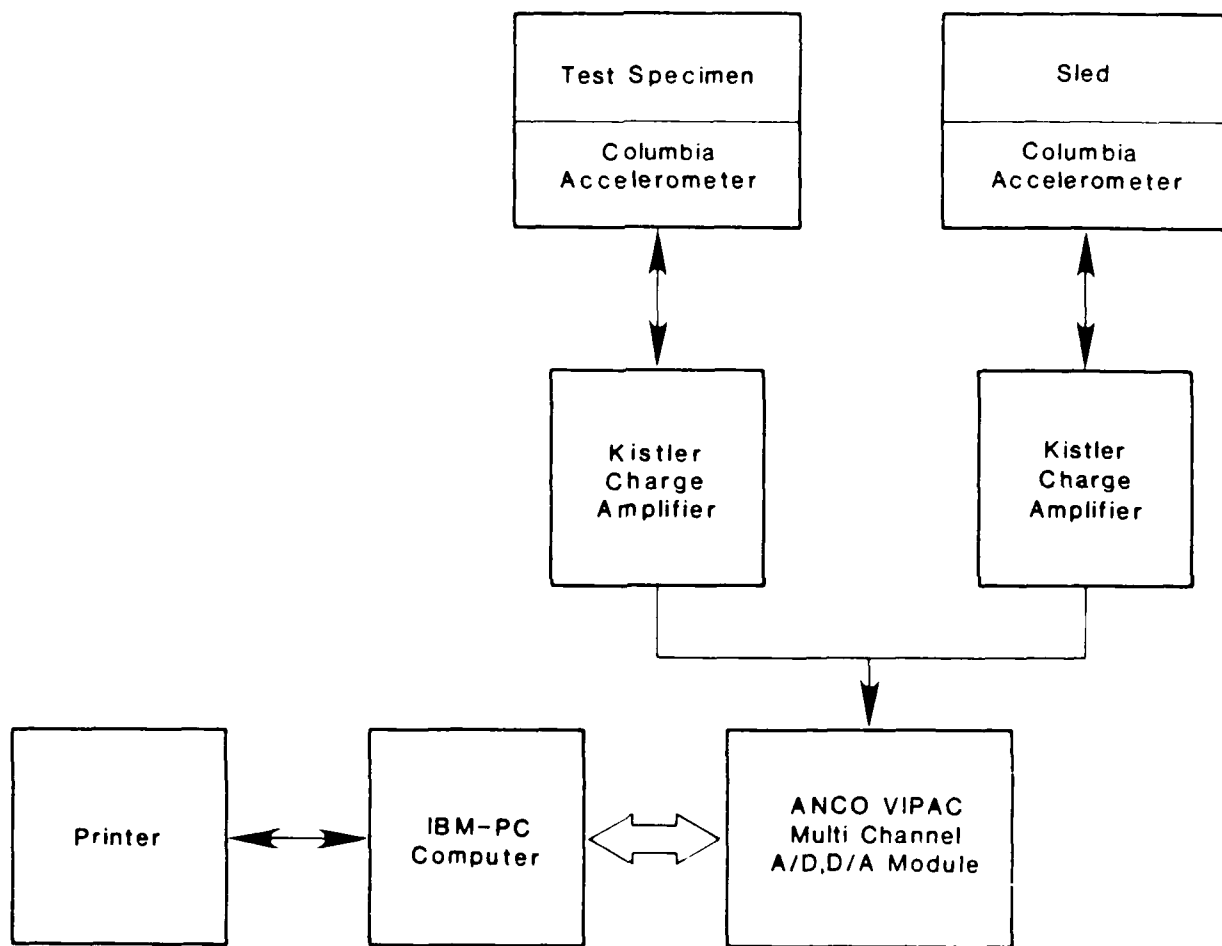
Figure 39. Block diagram of isolation testing system.

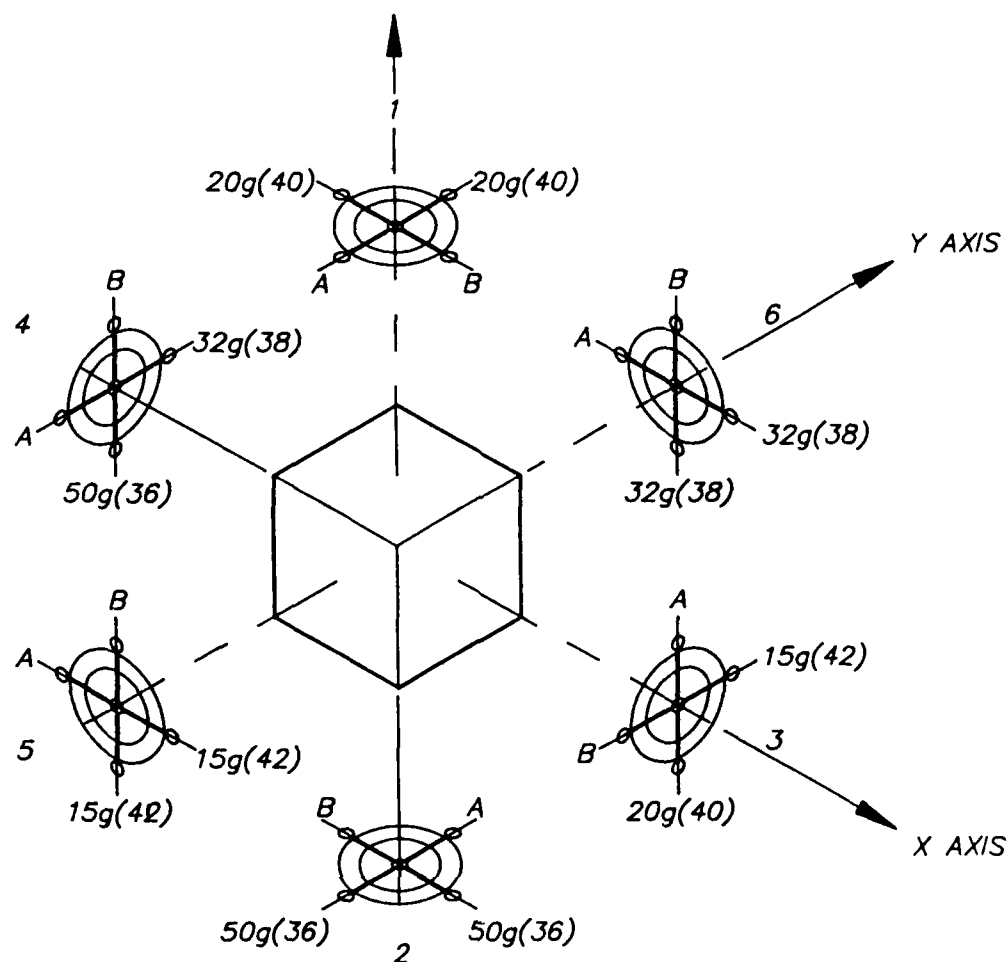
Figure 41. Slug-sensing wire arrangement.

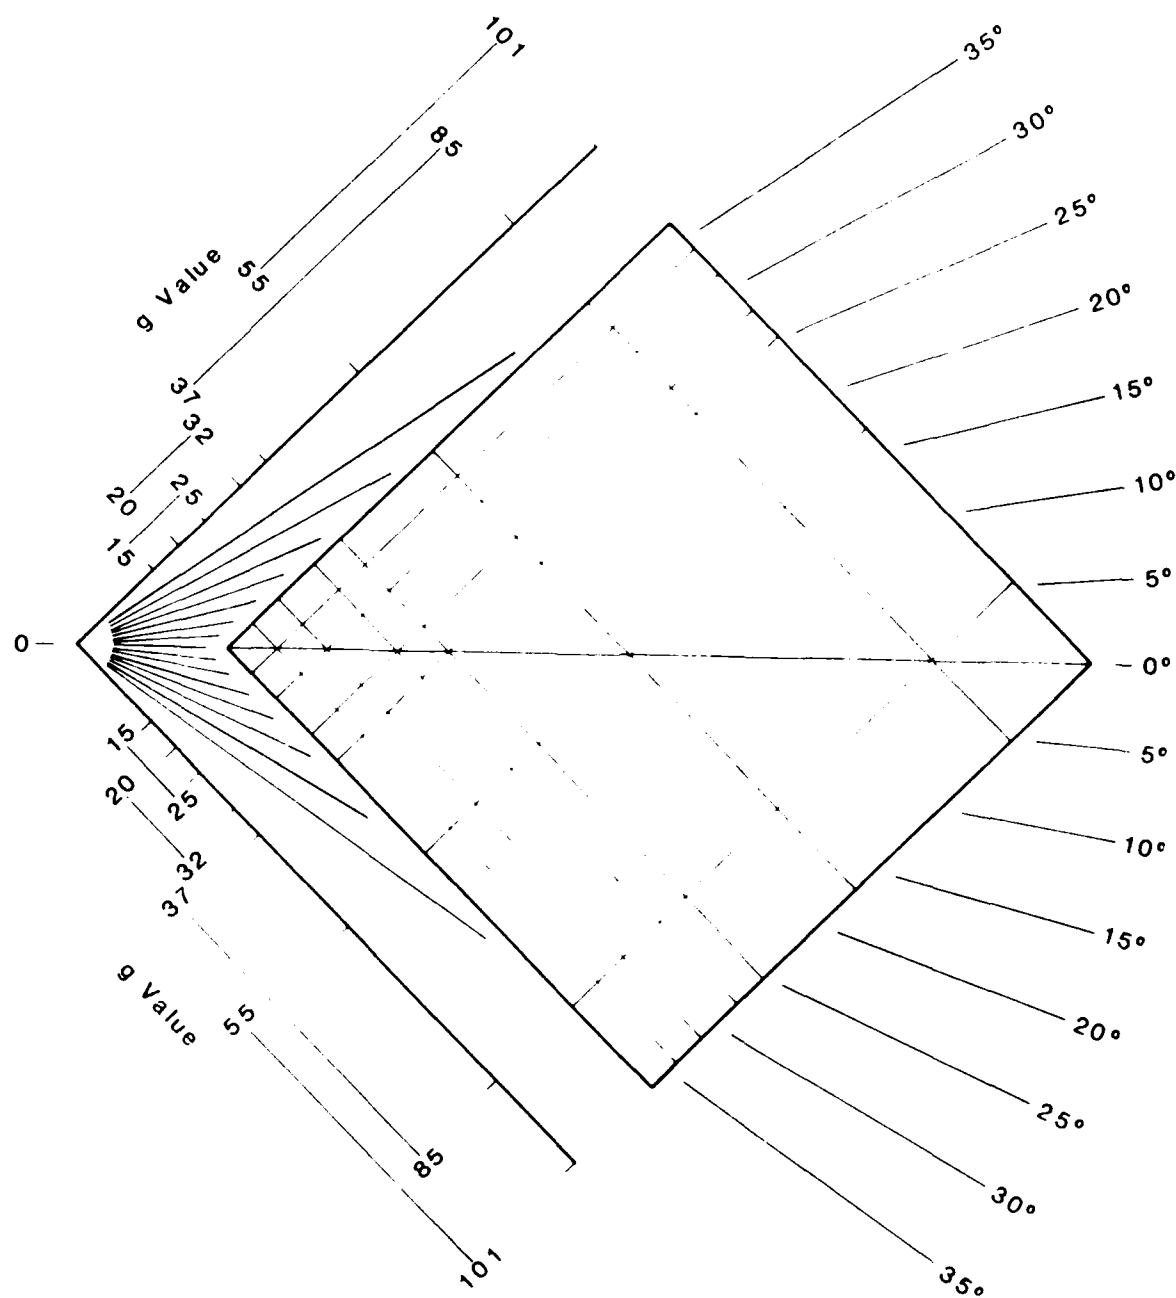
Figure 42. Peak g estimating chart.

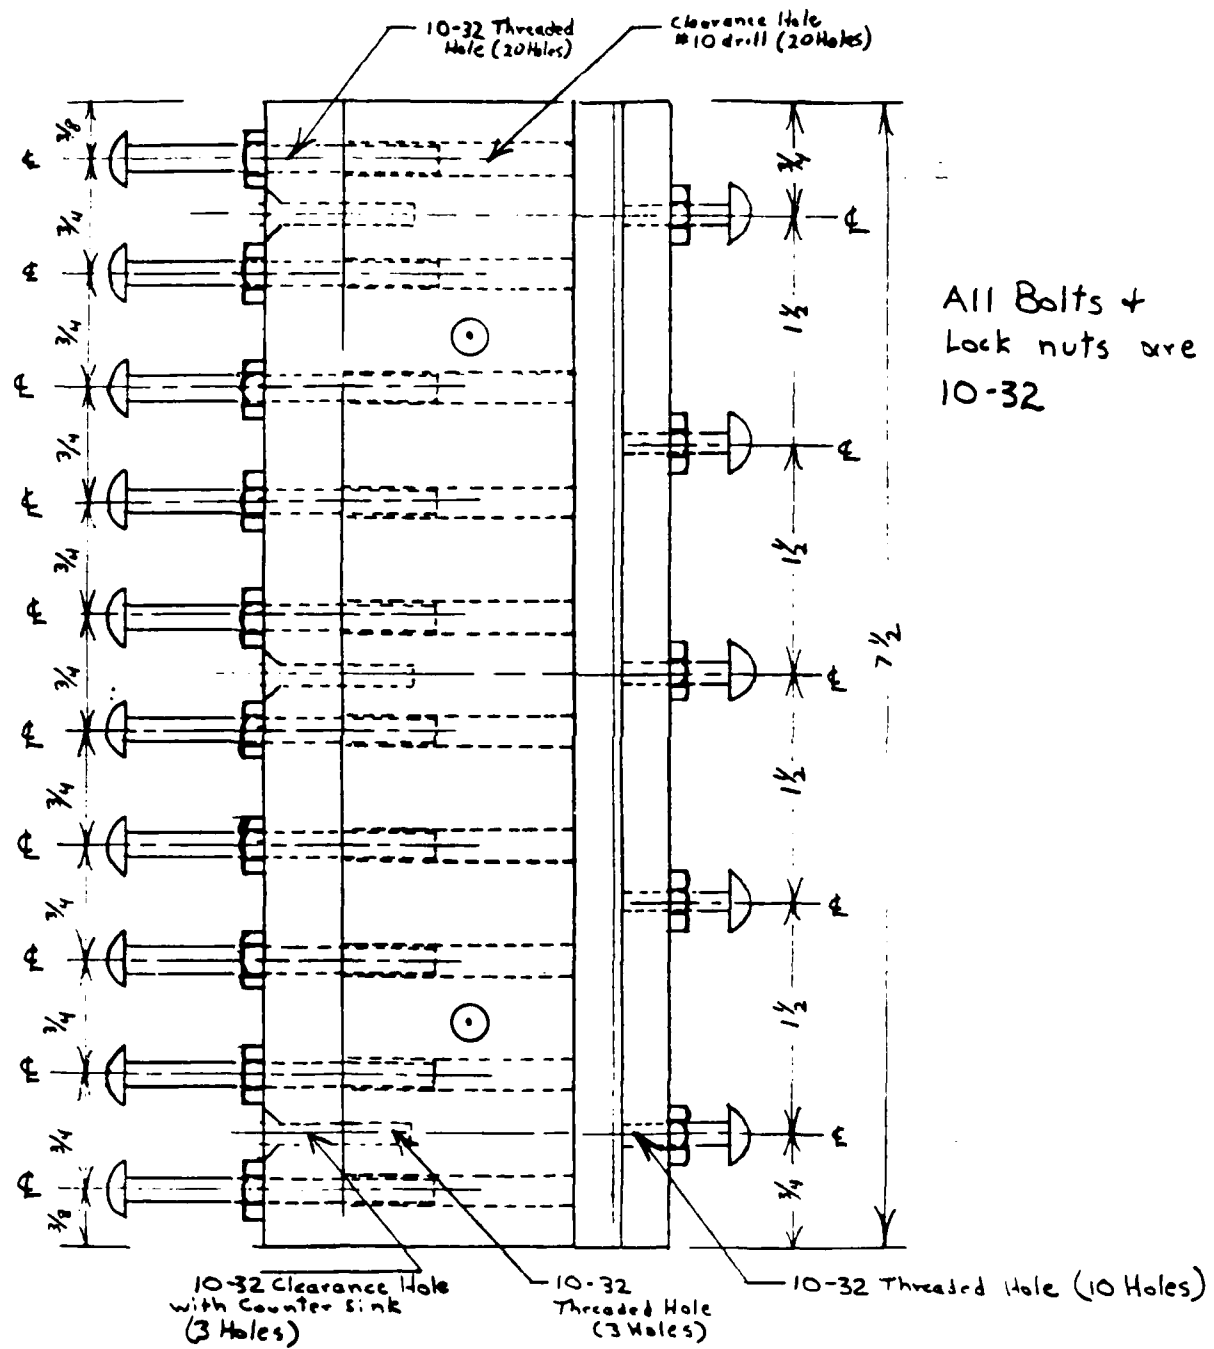
Figure 10. Drawing of multi test fixture.

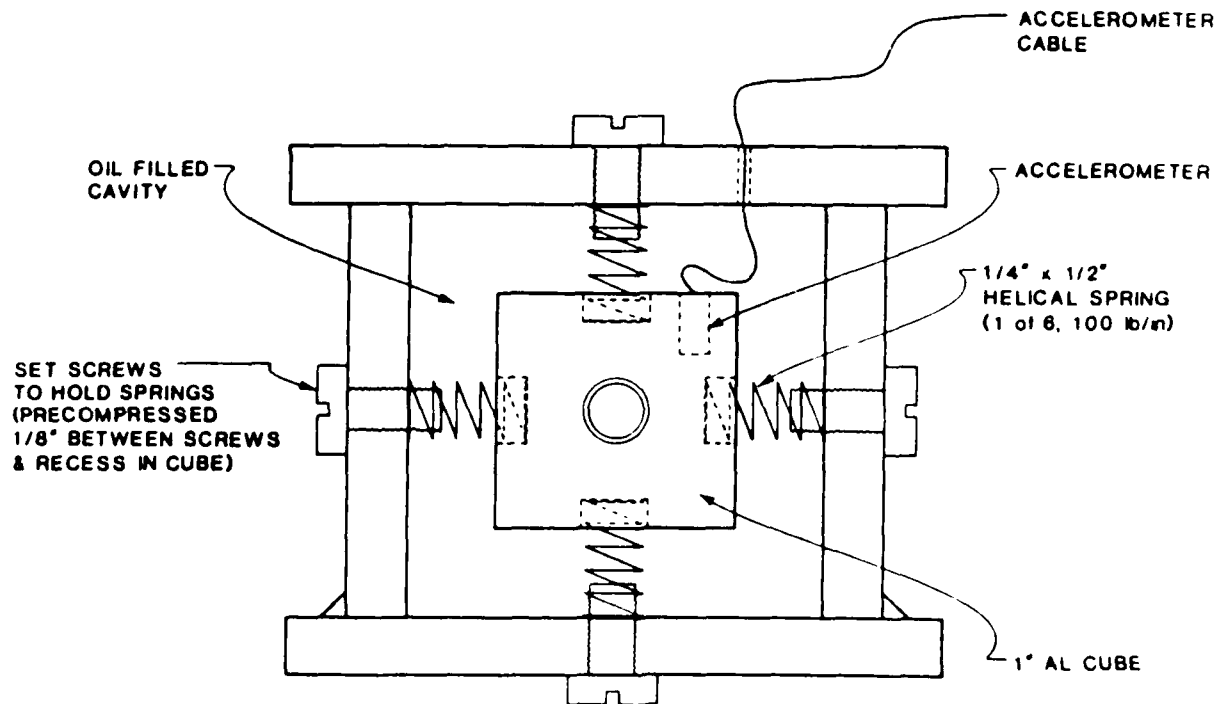
Cross Sectional View of Mechanical Filter Test Prototype

For reasons, similar to those that have convinced us to use metallic films rather than foam media for indicating, we have decided to use a helical spring system for the mechanical filter. This eliminates the nonlinearities found with foams and the concern over their environmental properties and aging stability. The current test prototype is illustrated below. It has an unclamped resonance of 97 Hz. The response measured in the crash sled is shown in Figures 1 and 3 and clearly indicate the strong attenuation of response above 100 Hz, as desired. The damping is provided by filling the cavity around the cube with oil. In our current experiment 80 weight petroleum based oil is used. In the final design a silicone oil will be used with temperature insensitivity and documented aging stability. (Tentatively General Electric SF96 appears adequate.)

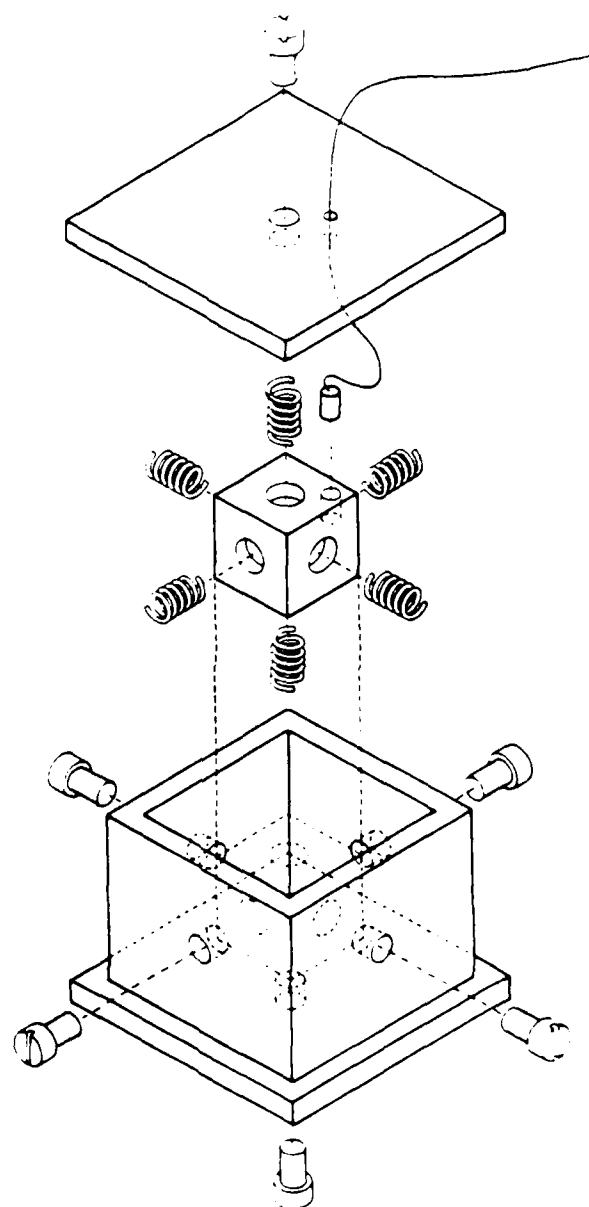
Exploded View of Mechanical Filter
Test Prototype
(Illustrating Triaxial Configuration)

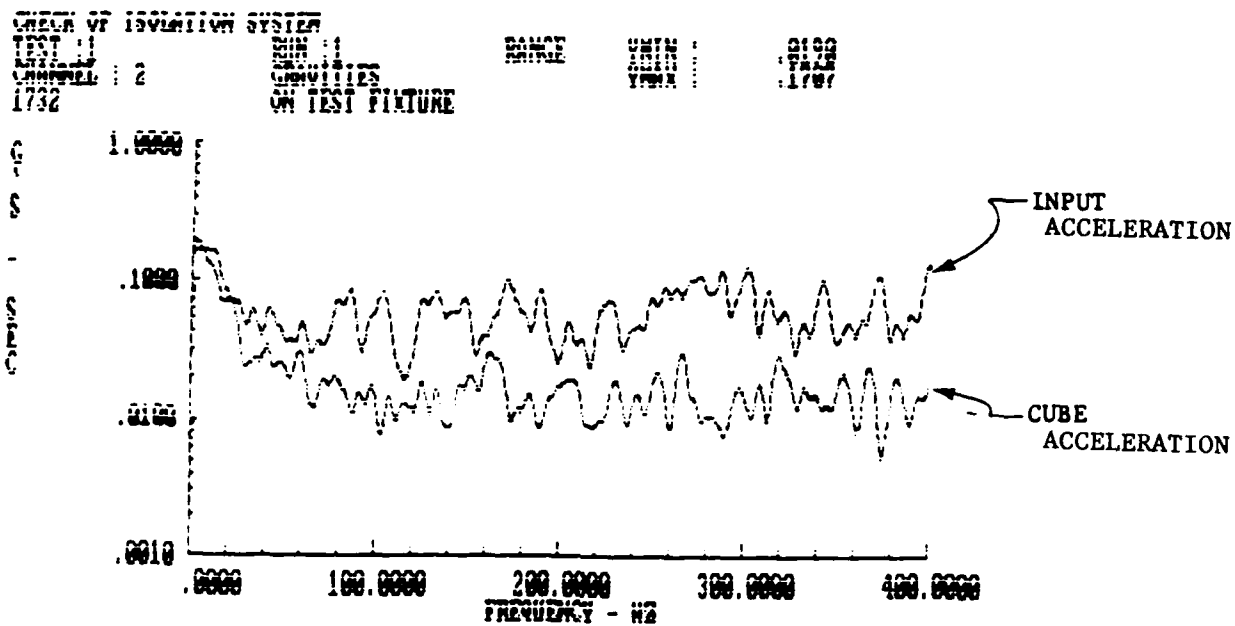
Figure 2.
 Fourier Transforms Showing
 Reduction of High Frequencies

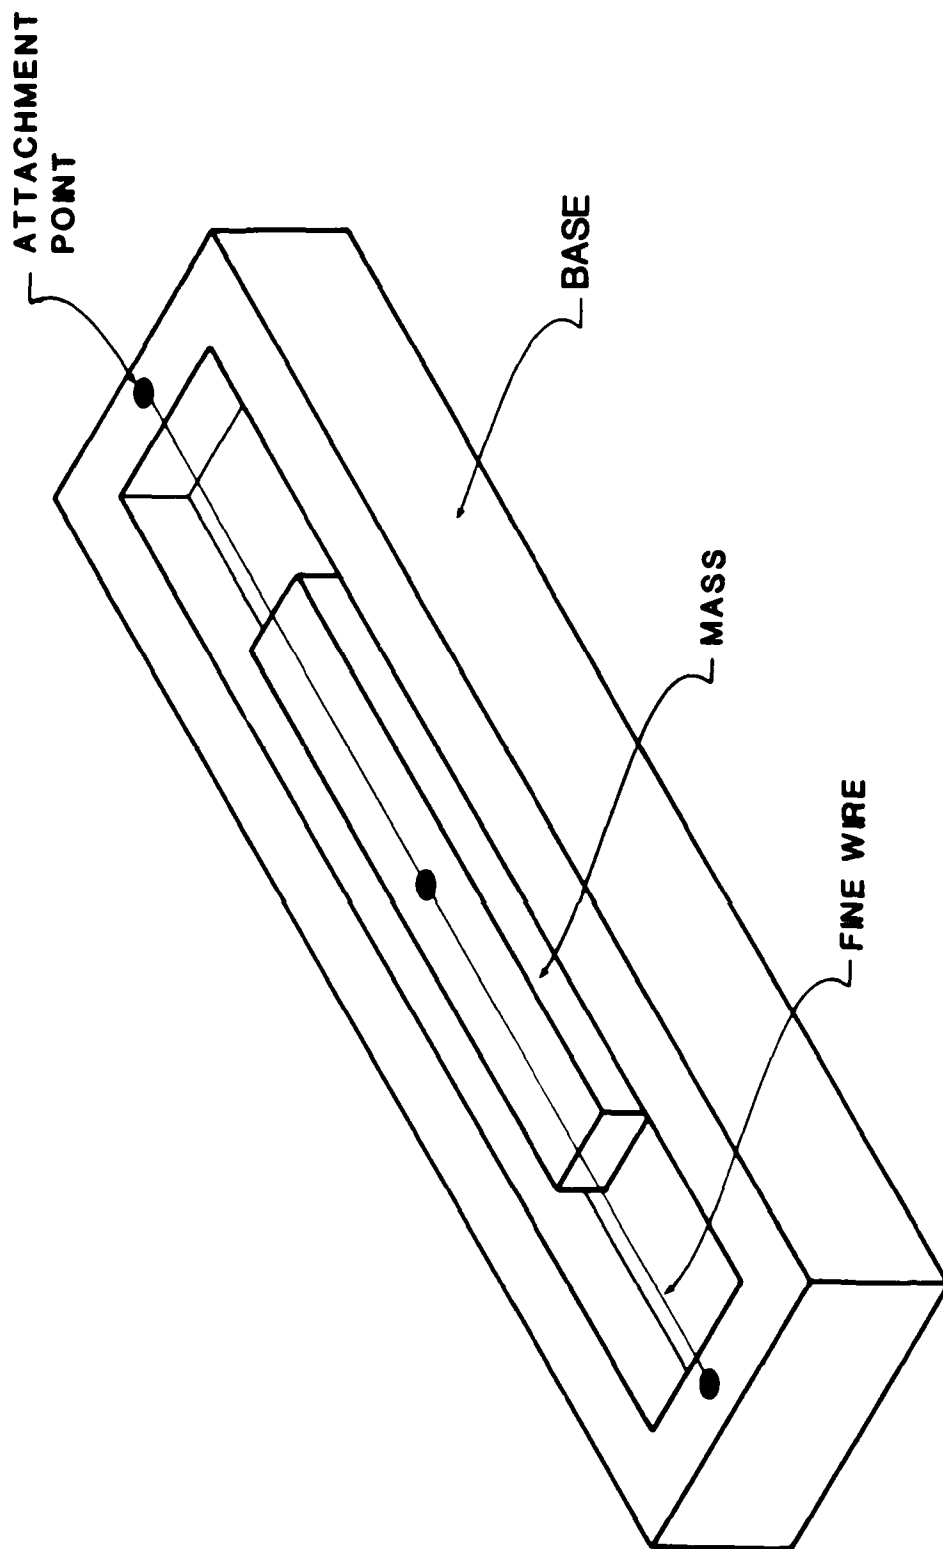
Figure 1. Mass - wire concept.

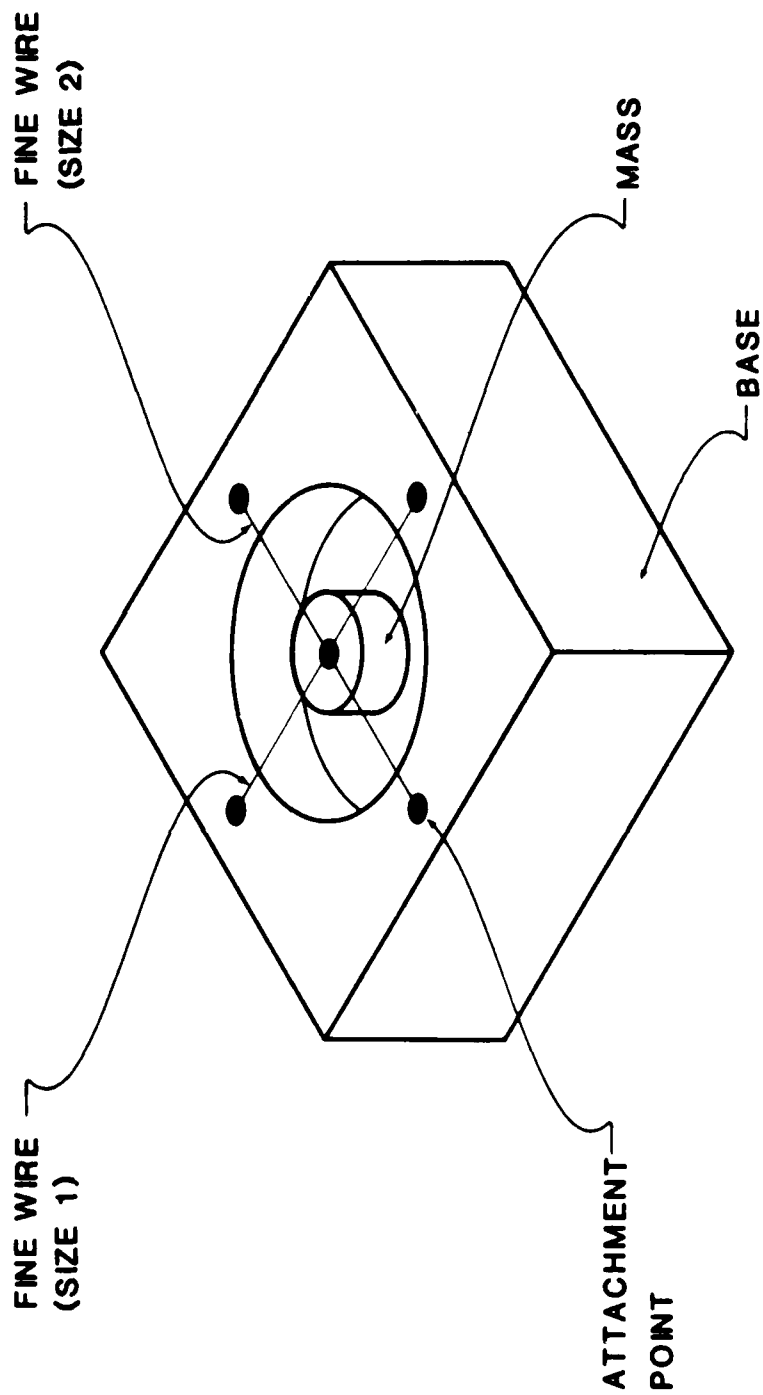
Figure 2. Dual mass wire configuration.

Once the wire/mass system was shown to be feasible we had to consider the packaging on the cube. In order to reduce size we were led to make dual use of each mass via a dual wire system (Figure 2). By attaching two perpendicular wires to

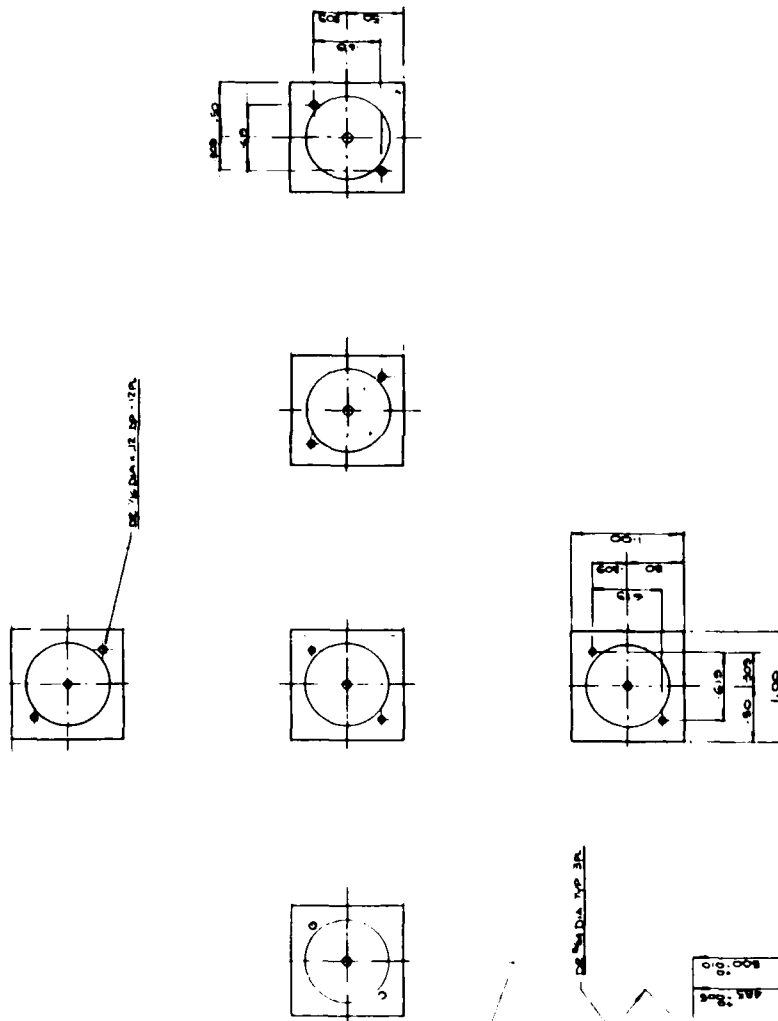
① CUBE
 MAT: 1.121/16 6061-T6 ALUMINUM BAR
 FINISH: ANODIZE PER MIL-A-8625 TYPE 2 CLASS 2 (BLACK)
